Using 3-dimensional terahertz pulsed imaging to analyse automotive coatings

Summary

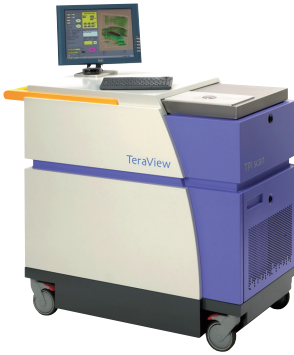
Figure 2.

Teraview TPI imaga 1000 imaging system (above and right).

Studies were conducted using TeraView's TPI™ imaga 1000 imaging system (Figure 2). Based on TeraView's proprietary technology, this stand-alone system enables the user to rapidly image any object in 3-dimensions.

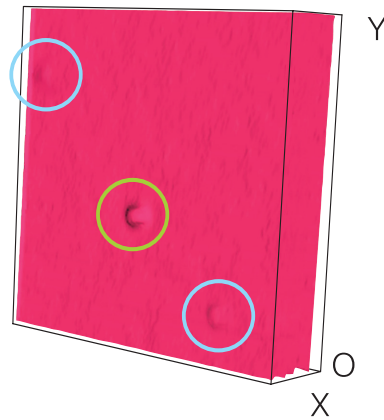
Figure 6.

Terahertz image of a 2" square from the test panel. The terahertz image is rotated such that we are looking from the back surface of the electrocoat layer. In this image three defects are detected, as circled. However only the defect circled green is detectable from the front surface by visual inspection. The defects circled blue are not apparent from visual inspection.

Figure 6 shows additional defects that are detected 3D TPI. Only one of these defects is observed from visual inspection.

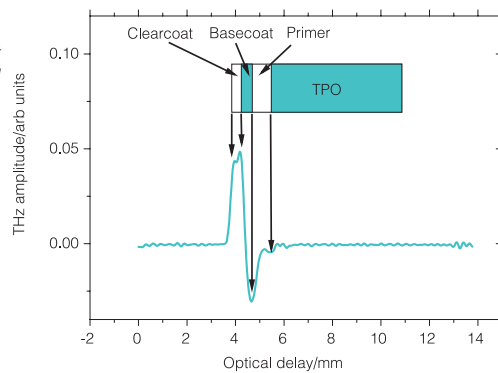
Figure 7.

Typical terahertz pulse of the test panel with a sheet-moulded compound (SMC) TPO substrate.

For a test panel with a TPO substrate, four peaks in the terahertz waveform were typically observed, as shown in Figure 7, separated by a distance that is dependent on the layer thickness. The first peak in the terahertz waveform is due to the reflection from the outer surface of the clearcoat. The second peak is due to terahertz reflection from the subsurface interface between the clearcoat and the basecoat. The third (negative) peak is due to terahertz reflection from the interface between the basecoat layer and the primer layer. The fourth peak is due to the reflection at the interface between the primer layer and the TPO substrate.

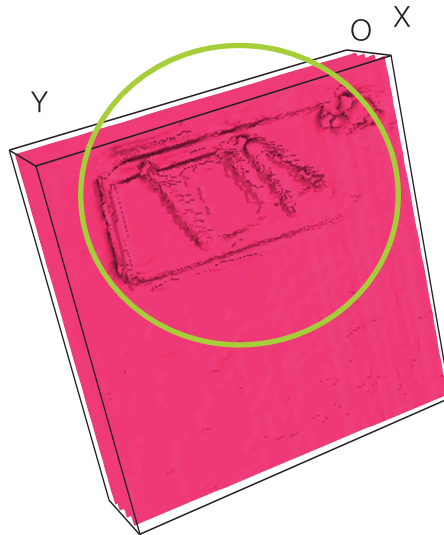
Photograph (top right) and 3-dimensional terahertz image of the TPO substrate test panel (below right). The THz image is rotated such that we are looking at the panel from the rear surface. The 3D TPI™ detects a defect (circled green) that cannot be seen by visual inspection.

A 3-dimensional image showing the location of the interfaces across a 2" area of a plastic test panel is shown in Figure 8. In this Figure we can see that a defect is present at the interface between the TPO substrate and the primer layer. This defect is not visible from very close inspection of the panel (by holding the panel at a very high angle to the eye). Figure 9 shows two 2-dimensional slices through the 3-dimensional image generated in Figure 8. The image below left has no defect present – here we can clearly monitor the thickness of the multiple layers through a non-contact method. Furthermore, in the image on the top left we can monitor the thicknesses of the multiple layers, and also at the same time visually identify the defect in the test panel. From inspection of Figures 8 and 9 we can see that the defect is the result of a bubble between the TPO substrate and the primer layer i.e. the primer layer has not adhered to the plastic in this region.
